**Flood Control Project Maintenance  
Levee Inspections**

**Fall 2018 Levee Maintenance Deficiency Summary Report**

**Sacramento River Basin**

**Flood Control Project Maintenance  
Levee Inspections****LMA District Cover Sheet****Fall 2018 Levee Inspection Results****California Department of Fish and Game Shea Levee**

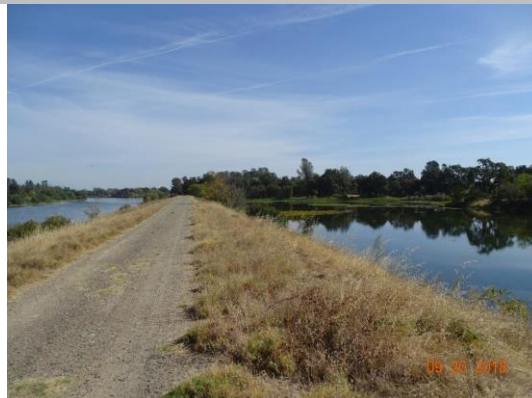
Photo 1 of 2 : FA\_2018\_NA0018\_269\_2\_20181008\_00006.jpg

LM Start	0.00	Rating **	M	Issue No.	2
LM End	0.30	Issue Type +	Ma	Location *	LS
Category	Earthen Levee			GPS Latitude/Longitude	
				Start	End
Item	Vegetation			40.507697°	40.511210°
				-122.363683°	-122.360390°
DWR ID	DWR_NA0018_01_s_2012_2				
Comment Code					
V2 : Remove the wild growth other than native grasses from the levee slopes.					
Inspector Comment					
California Department of Fish and Wildlife has not completed any maintenance several year.

View of the vegetation along the landside slope.

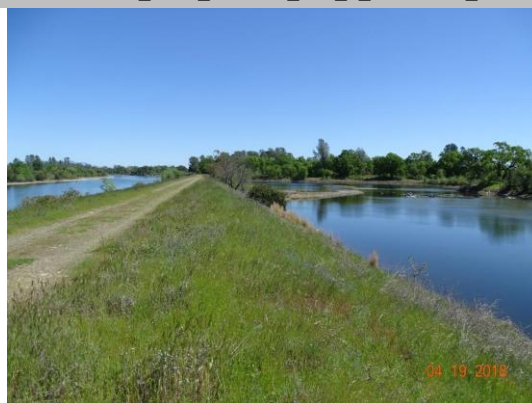
Photo 2 of 2 : FA\_2018\_NA0018\_269\_2\_20180905\_00003.jpg

View of the vegetation along the landside slope.

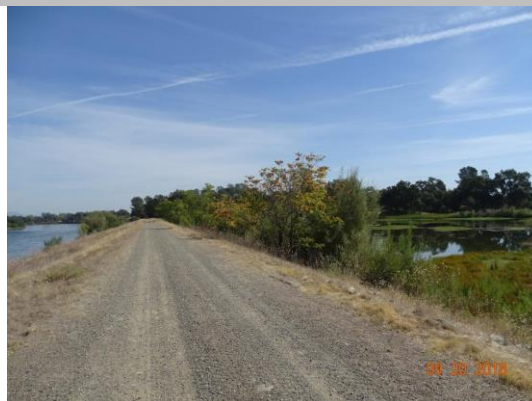
Photo 1 of 1 : FA\_2018\_NA0018\_269\_3\_20181008\_00008.jpg

LM Start	0.00	Rating **	M	Issue No.	3
LM End	0.30	Issue Type +	Ma	Location *	LS
Category	Earthen Levee			GPS Latitude/Longitude	
				Start	End
Item	Trim / Thin Trees			40.507738°	40.511210°
				-122.363682°	-122.360390°
DWR ID	DWR_NA0018_01_f_2017_3				
Comment Code					
T3 : Trim and thin trees to allow visibility of the ground and room to flood fight.					
Inspector Comment					
Trim and remove trees to allow visibility.

View of the trees along the landside slope.

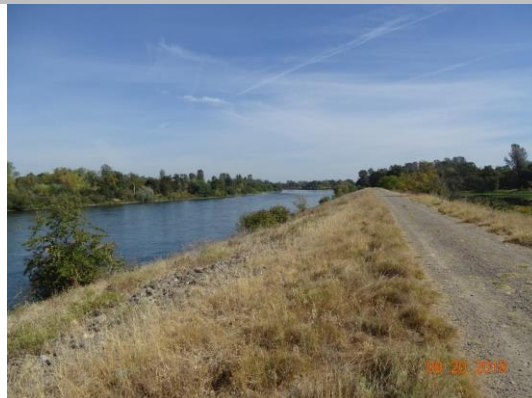
Photo 1 of 2 : FA\_2018\_NA0018\_269\_1\_20181008\_00007.jpg

LM Start	0.00	Rating **	M	Issue No.	1
LM End	0.30	Issue Type +	Ma	Location *	WS
Category	Earthen Levee			GPS Latitude/Longitude	
				Start	End
Item	Vegetation			40.507697°	40.510670°
				-122.363683°	-122.361203°
DWR ID	DWR_NA0018_01_s_2012_1				
Comment Code					
V2 : Remove the wild growth other than native grasses from the levee slopes.					
Inspector Comment					
Remove the vegetation from the waterside slope.

View of the vegetation along the waterside slope.

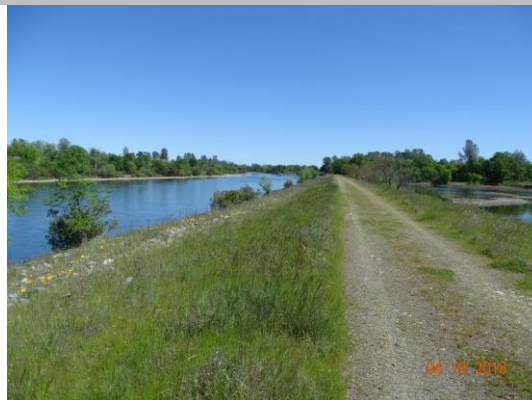
Photo 2 of 2 : FA\_2018\_NA0018\_269\_1\_20180905\_00001.jpg

View of the vegetation along the waterside slope.
